# **PRELIMINARY INVESTIGATION REPORT**

**ACCIDENT OF PIA FLIGHT PK8303 AIRBUS A320-214  
REG NO AP-BLD CRASHED NEAR KARACHI AIRPORT  
ON 22-05-2020**

### **ACCIDENT OF PIA FLIGHT PK8303 AIRBUS A320-214 REG NO AP-BLD NEAR KARACHI AIRPORT ON 22-05-2020**

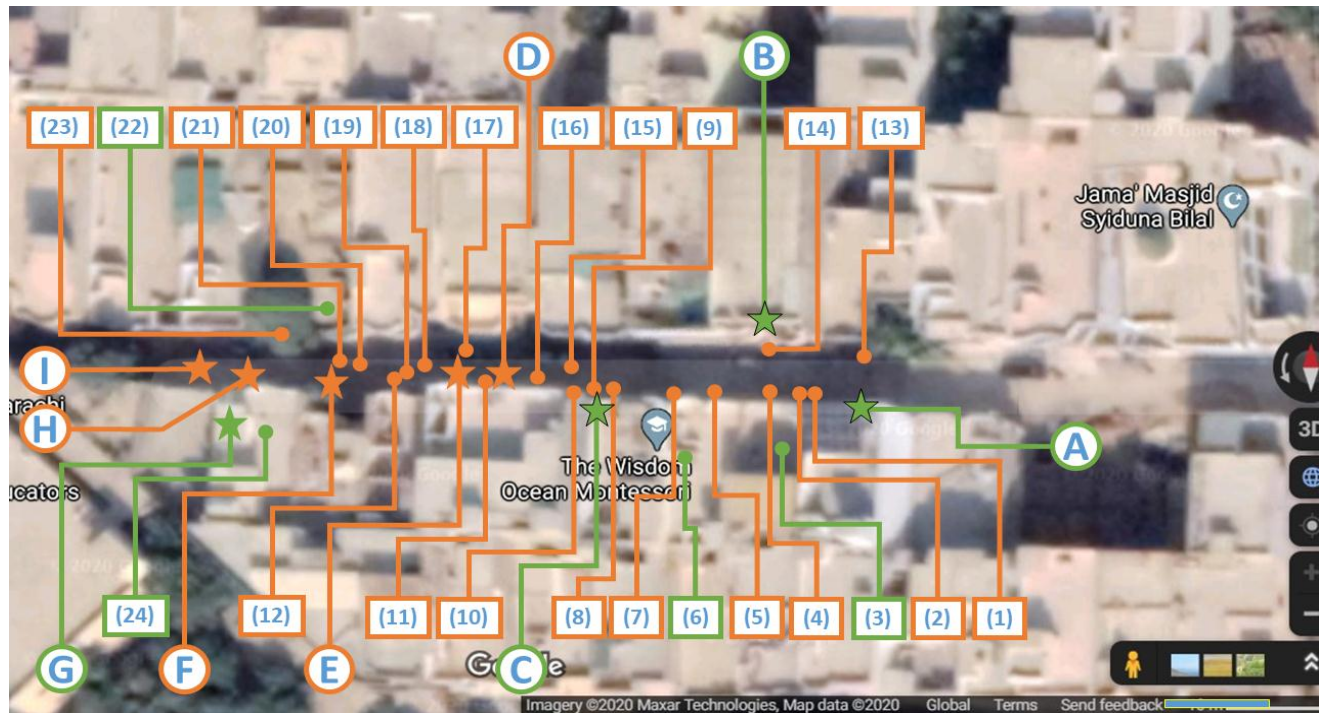
Fig 3 : Wreckage mapping (Google Maps)

12. The layout of the aircraft parts on the accident site is consistent with the aircraft impacting buildings on both sides of the street at low speed. The THSA position before the impact was determined to be 2.8 deg nose up. According to the Rudder Travel Limiting Unit, the aircraft speed before impact was below 150 knots IAS. Several findings indicate an extended landing gear configuration at the time of impact. The free fall mechanism for lowering of landing gears was not used. The slat / flap configuration was determined to be in position slat 1 (ie 18 deg), flaps fully retracted (0 deg). The RAT was seen deployed on CCTV screen shots prior impact.

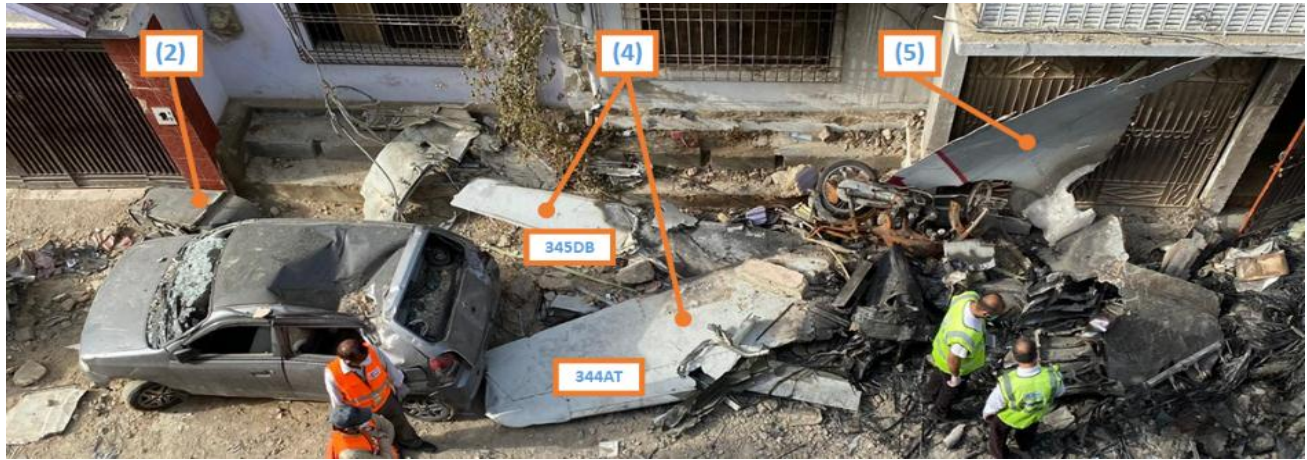
Fig 4 : View of the eastern side of the street

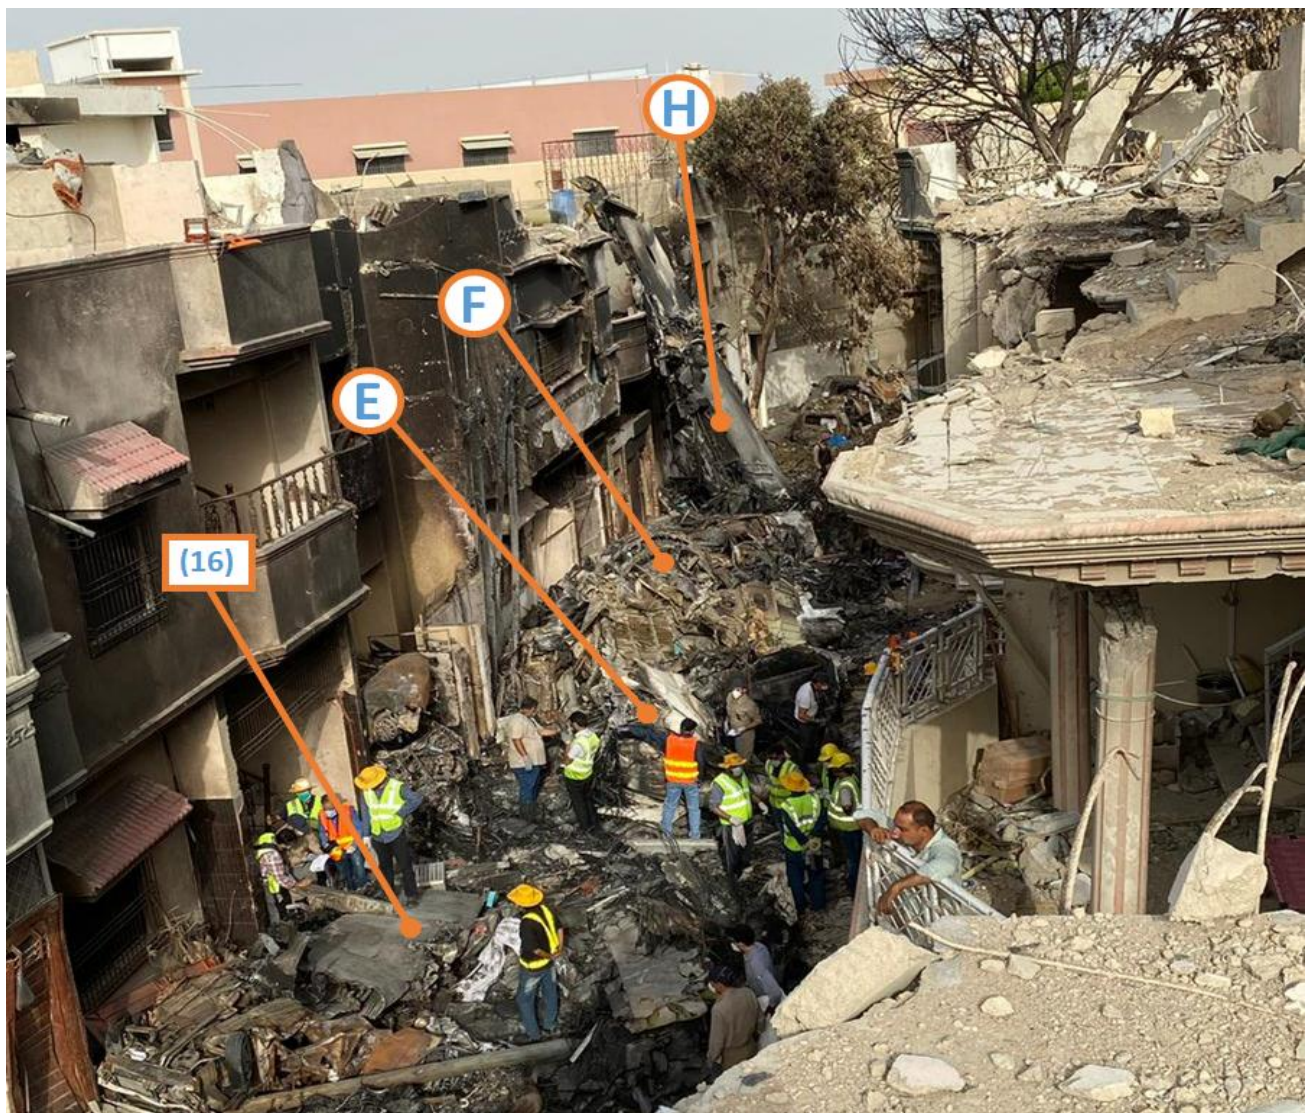
Fig 5 : View of the middle of the street looking towards the western end of the street

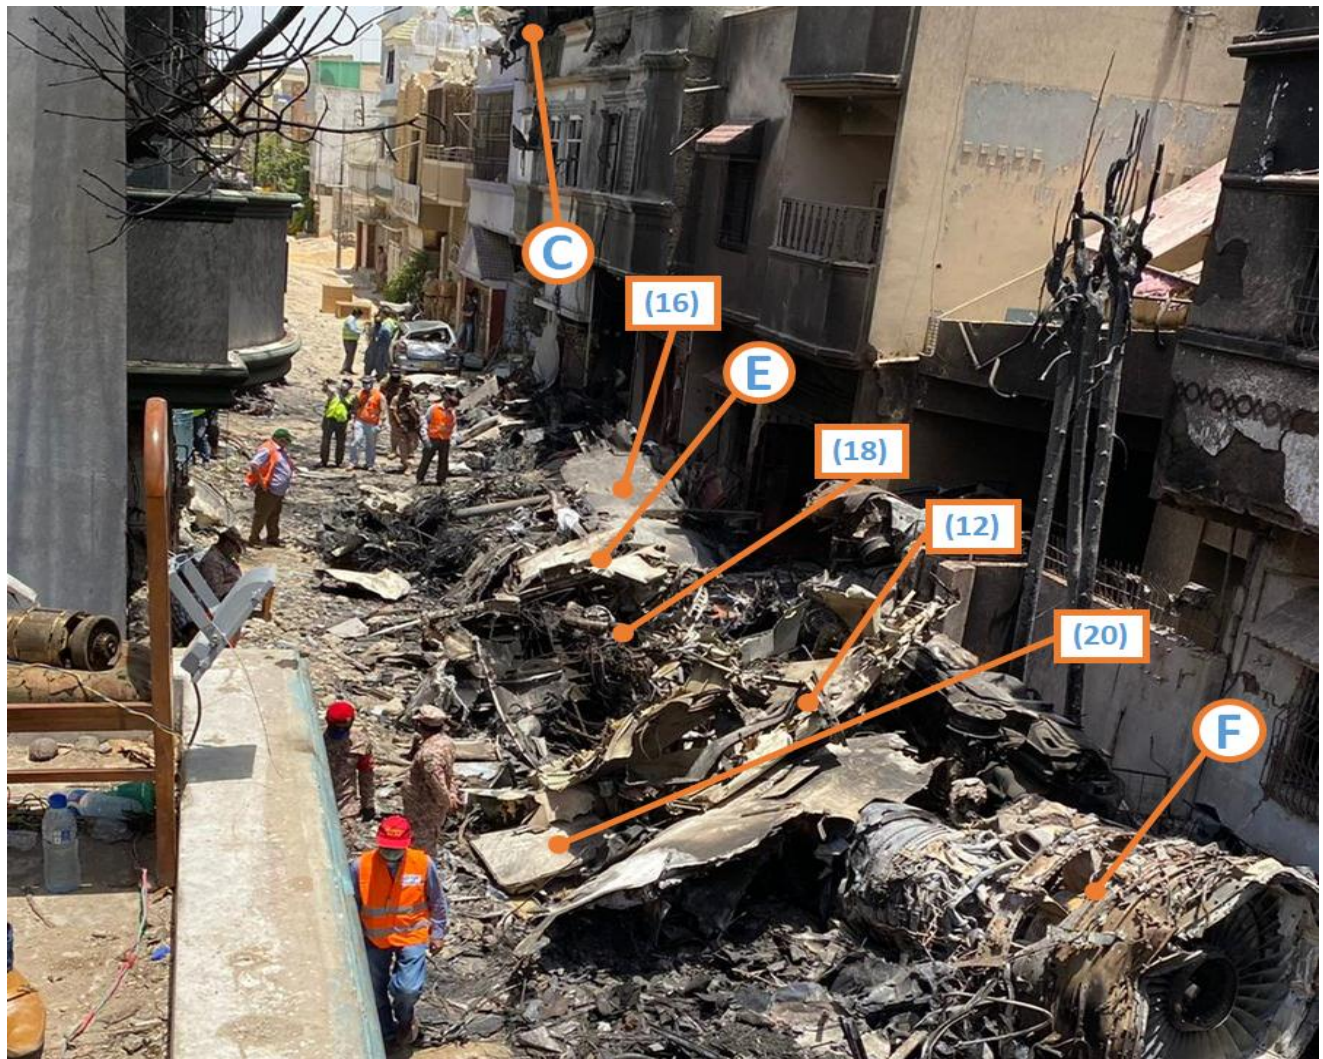
Fig 6 : View from western end of the street looking towards eastern side

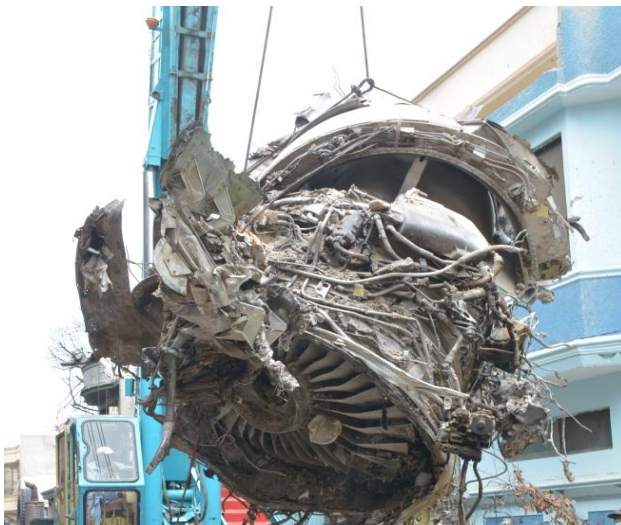
13. Left engine showed evidence of external fire. Visible fan blades condition was consistent with the engine being at low rotational speed at the time of impact, most likely not producing any thrust. Right engine showed evidence of external fire. Fan blades were in good condition being consistent with the engine at low rotational speed at the impact, most likely not producing any thrust at time of impact.

Fig 9 : Left engine being lifted from roof top

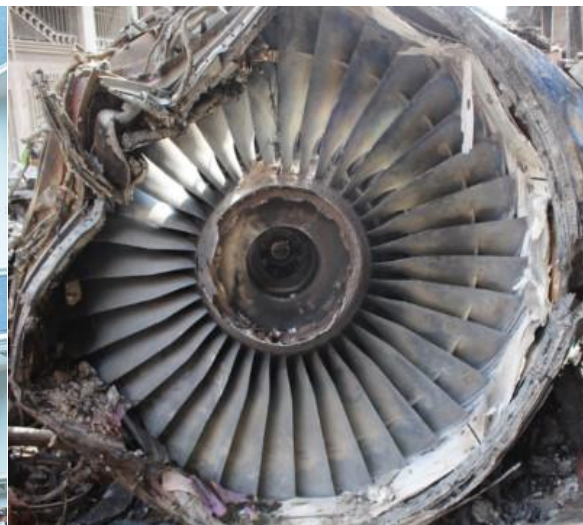
Fig 10 : Right engine

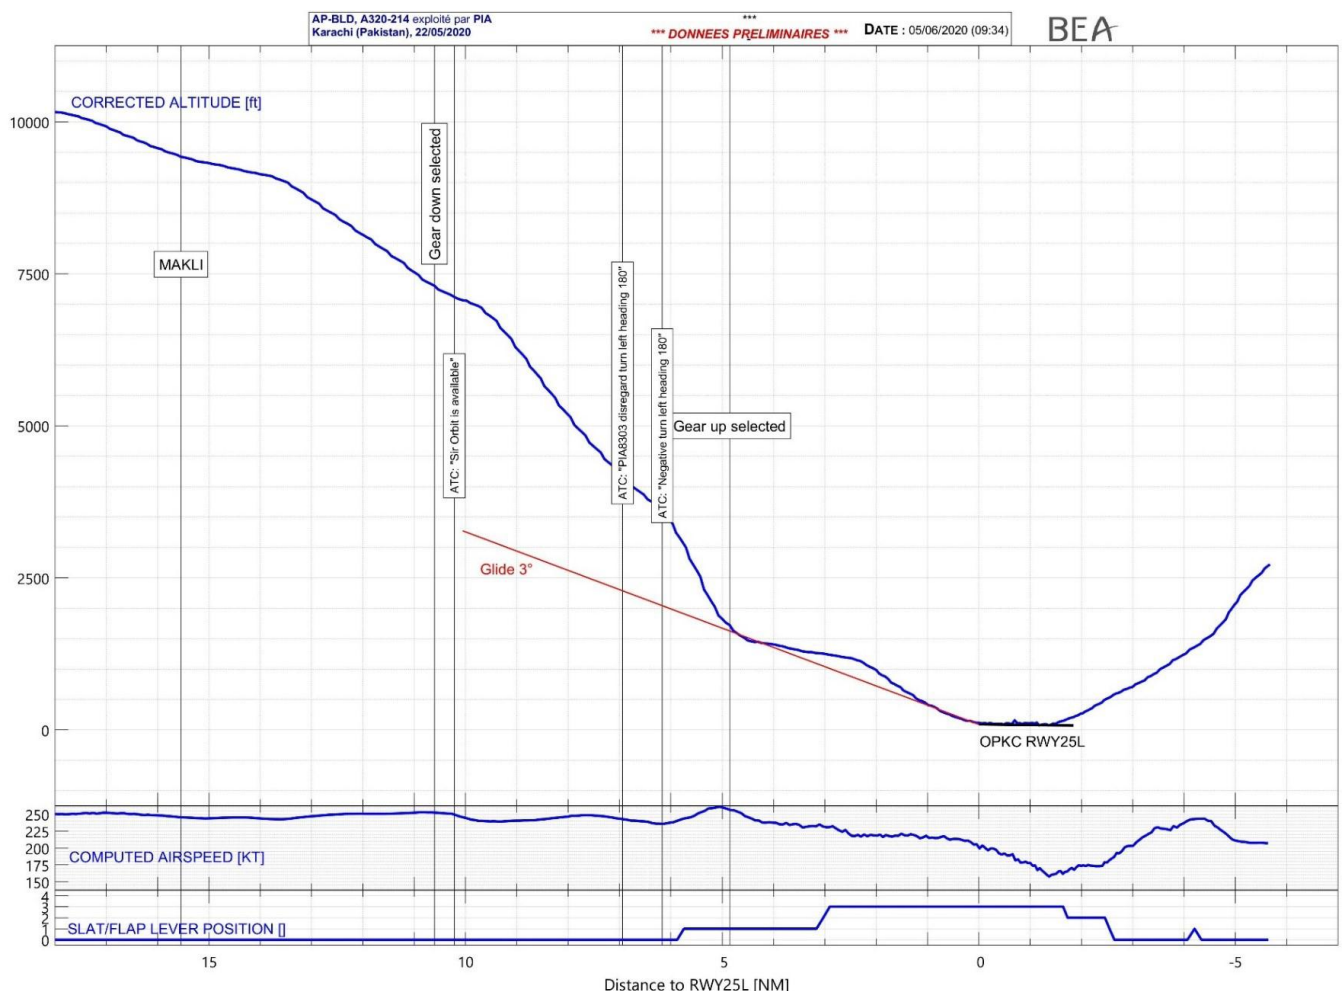
(f) “Karachi Approach” advised repeatedly (twice to discontinue the approach and once cautioned) about excessive height. Landing approach was not discontinued. However, FDR shows action of raising of the landing gears at 1740 ft followed by retraction of the speed brakes (at a distance slightly less than 05 nautical miles from the runway 25L). At this time, the aircraft had intercepted the localizer as well as the glide slope. Flaps 1 were selected at 243 knots IAS, the landing gears and speed brakes were retracted. Over-speed and EGPWS warnings were then triggered.

Fig 21 : Selected FDR parameters during last part of the first approach

(i) At 500 ft, the FDR indicates: landing gear retracted, slat/flap configuration 3, airspeed 220 knots IAS, descent rate 2000 ft/min. According to the FDR and CVR recordings several warnings and alerts such as over-speed, landing gear not down and ground proximity alerts were disregarded. The landing was undertaken with landing gears retracted. The aircraft touched the runway surface on its engines. Flight crew applied reverse engine power and initiated a braking action. Both engines scrubbed the runway at various locations causing damage to both of them. Figures hereunder show selected screenshots of security / CCTV cameras footages of the aircraft engines touching the runway and showing sparks due to scrubbing, along with marks on the runway.

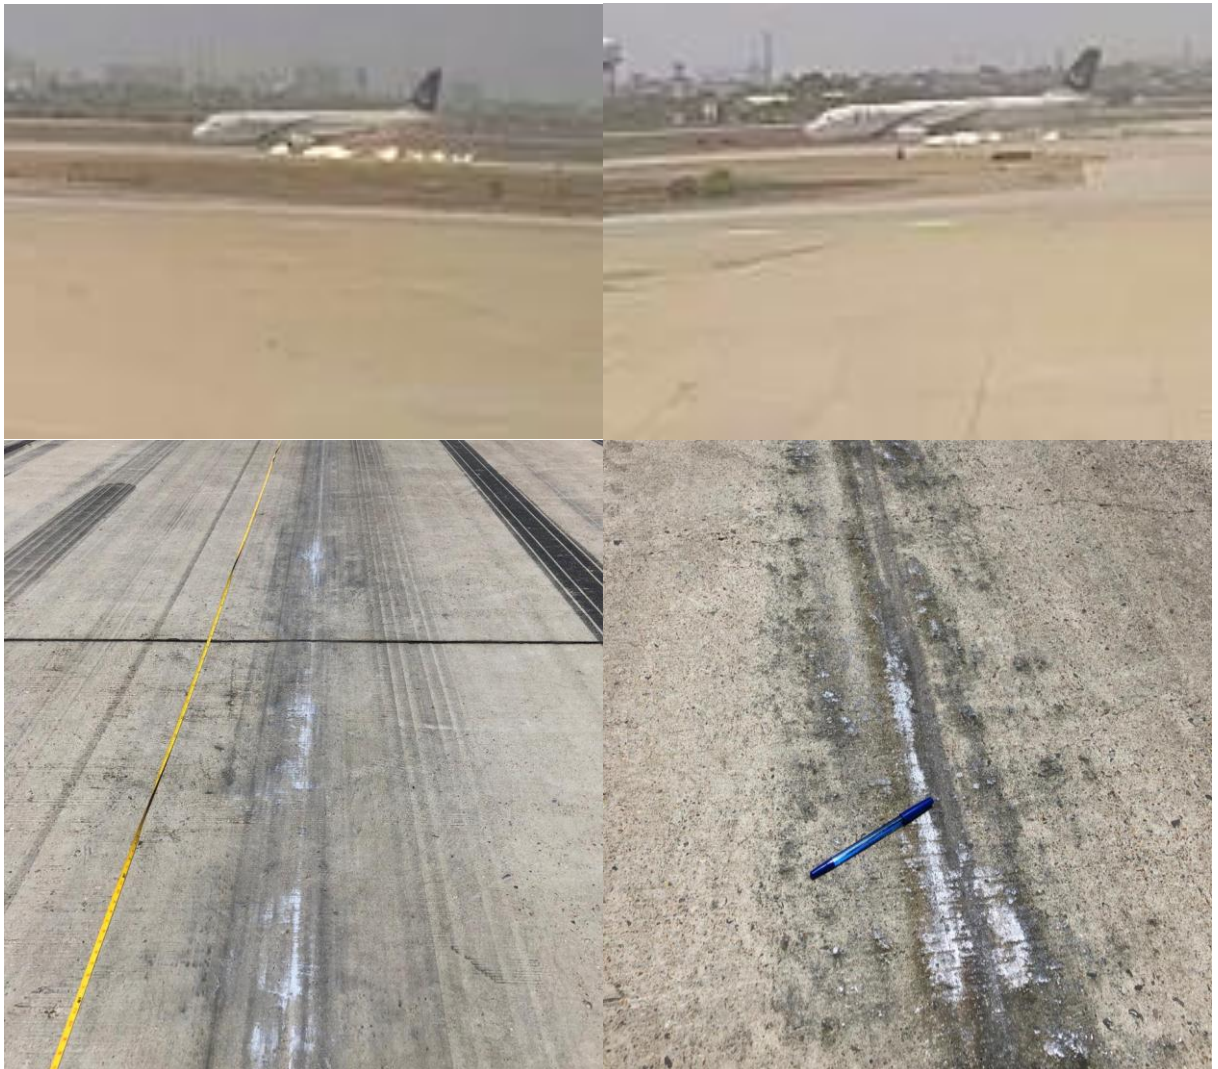
14. Transfer gearbox and drain mast reservoir, located at the engine lower part showed marks of friction with hard flat surface, material displacement and loss of material. It was consistent with the CCTV footages showing the lower part of the engine scrubbing the runway during the first landing attempt. The APU air intake flap actuator was not in the "retracted" position, consistent with the APU not being used at the time of impact, ie not

Fig 22 : Screenshots of security / CCTV cameras footages, and marks on runway
