# Interim Report

| Type of Occurrence: | Serious incident |
| Manufacturer / Model: | Boeing / B737-800 |
| State File Number: | BFU EX002-12 |

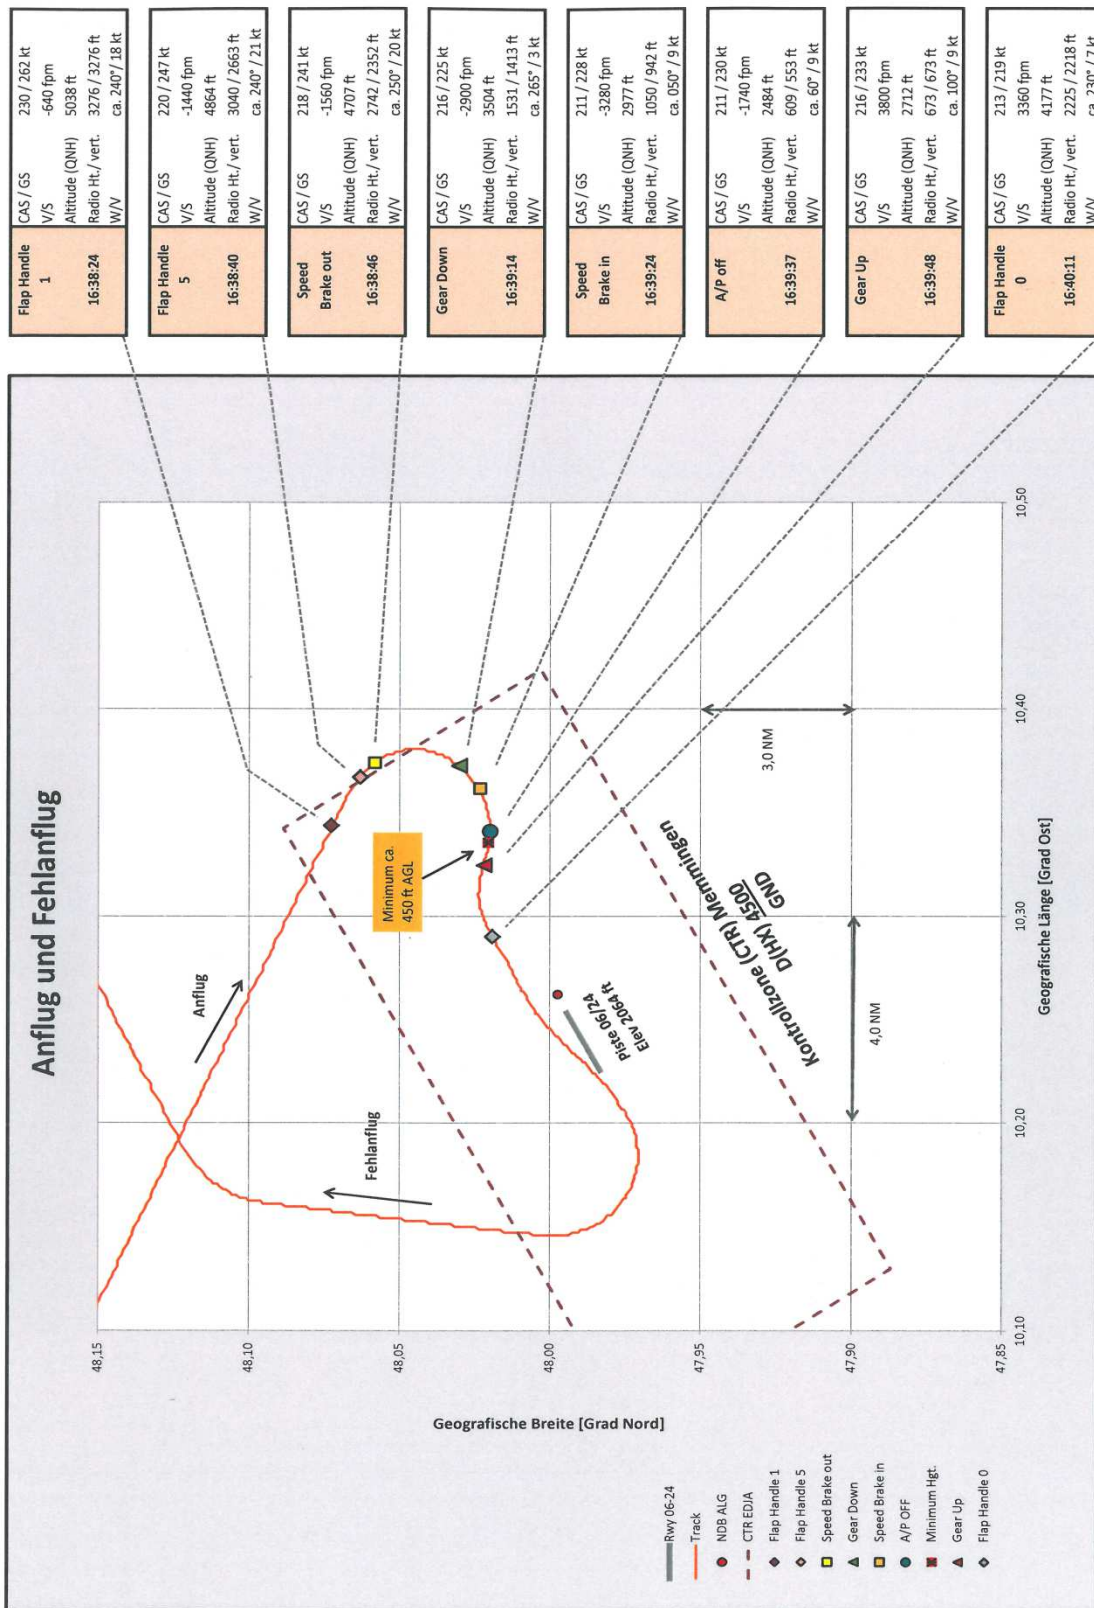
## Appendix 1:

Then the crew initiated a right-hand turn using the autopilot and continued the descent. An altitude of 2,096 ft AMSL had been pre-selected. Appendix 1 shows a graph of the continued approach.

At 1639:20 hrs the EGPWS generated the warning "Sink Rate". At the time the airplane was in 1,319 ft AGL with a rate of descent of about 3,240 ft/min and a bank angle to the right of about 25°.

At 1639:40 hrs the EGPWS generated the warning "Caution Terrain". At the time the airplane was in 480 ft AGL with a rate of descent of about 500 ft/min and a bank angle to the left of about 35°.

At 1639:41 hrs the B737 reached the lowest flight altitude of about 450 ft AGL.

At 1639:42 hrs the EGPWS generated the warning "Terrain, Terrain, Pull up, Pull up". At the time the airplane was in 460 ft AGL with a **rate of climb**\* of about 600 ft/min and a bank angle to the left of 7°.
