# Search for the X-15

# NORTH AMERICAN X-15

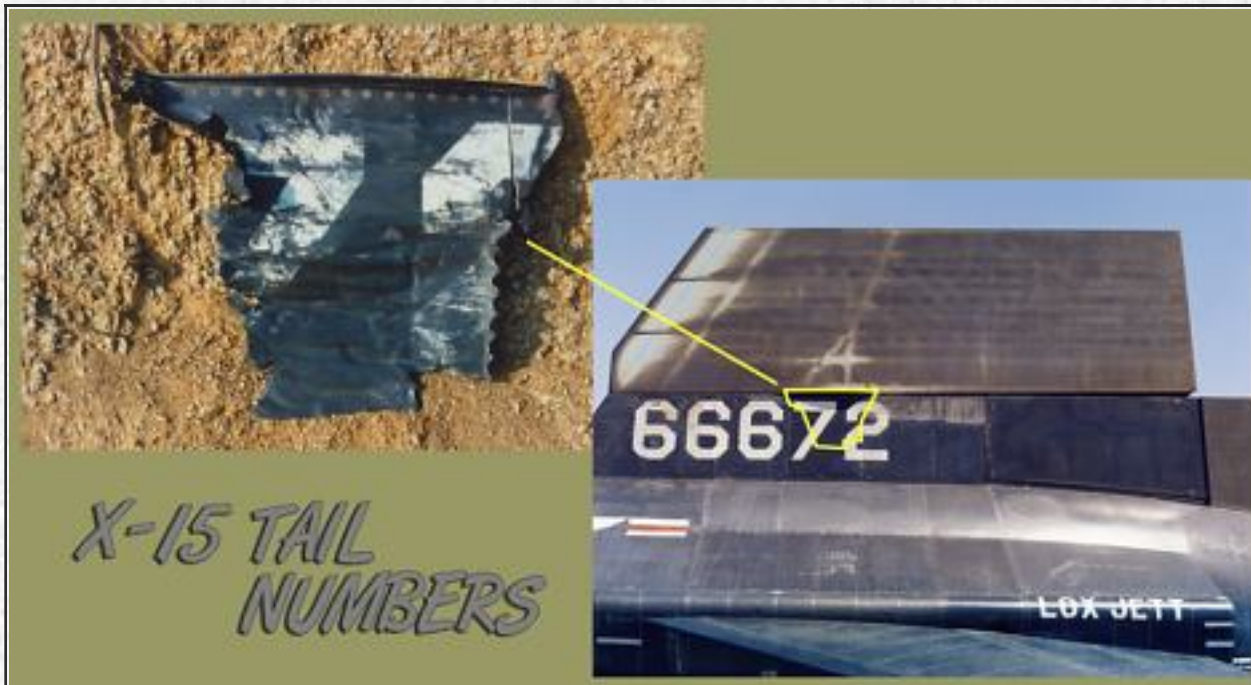
**X-15 TAIL NUMBER FRAGMENT** THIS PIECE OF THE UPPER VERTICAL STABILIZER BEARS PART OF A FADED WHITE "72", REMNANTS OF THE X-15's LAST TWO TAIL NUMBERS, SHOWN OUTLINED IN A PHOTO OF THE COMPLETE RUDDER AND STABILIZER ON THE RIGHT. THE FRAGMENT WAS CREATED AS THE RUDDER TORE ITSELF LOOSE FROM THE AIRCRAFT AS IT BROKE UP HIGH ABOVE THE MOJAVE DESERT  
THIS ARTIFACT IS NOW PART OF THE AIR FORCE FLIGHT TEST CENTER MUSEUM COLLECTION

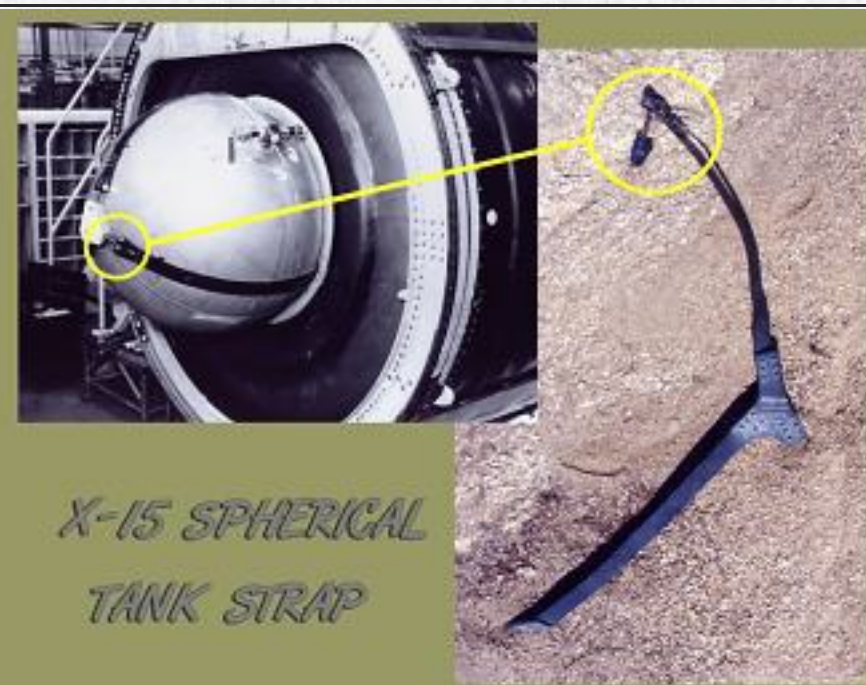
**X-15 SPHERICAL TANK STRAP** THIS TITANIUM STRAP WAS USED TO SECURE A SPHERICAL TANK OF HELIUM, WHICH WAS SIMILAR TO THE TURBOPUMP FUEL TANK PICTURED ABOVE. THE HELIUM WAS USED TO PURGE OTHER GASES FROM THE XLR-99 ROCKET ENGINE. CIRCLED IS ONE OF THE THREE ADJUSTABLE FASTENERS THAT JOINED THE STRAP TOGETHER

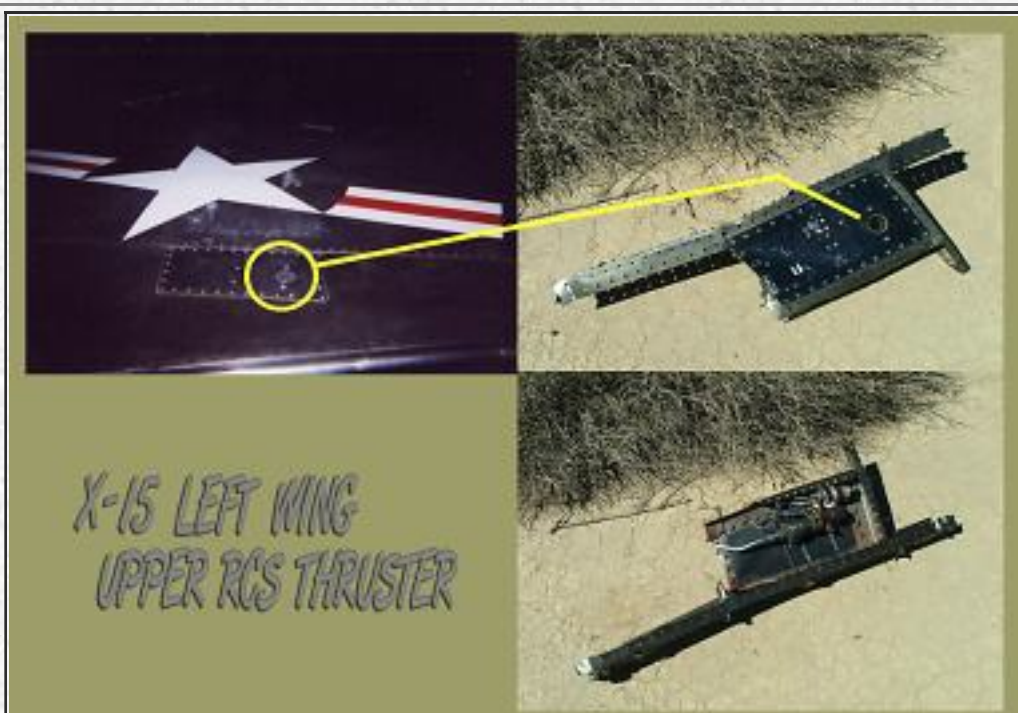
**X-15 RCS THRUSTER** THE PHOTOS ON THE RIGHT SHOW A TOP AND BOTTOM VIEW OF ONE OF THE X-15's REACTION CONTROL SYSTEM THRUSTERS THAT WERE USED TO CONTROL THE VEHICLE WHILE IN THE VACUUM OF SPACE. THIS ONE, ONCE MOUNTED IN THE UPPER SIDE OF THE LEFT WING IS IDENTICAL TO THE ONE IN THE PHOTO OF THE #2 X-15's WING SHOWN ABOVE. THE THRUSTER ASSEMBLY IS STILL ATTACHED TO A SECTION OF THE WING'S STRUCTURE AND, IF YOU LOOK CLOSELY, REMNANTS OF THE WHITE "BEWARE OF BLAST" WARNING PLACARD CAN BE STILL BE SEEN NEXT TO THE THRUSTER'S NOZZLE

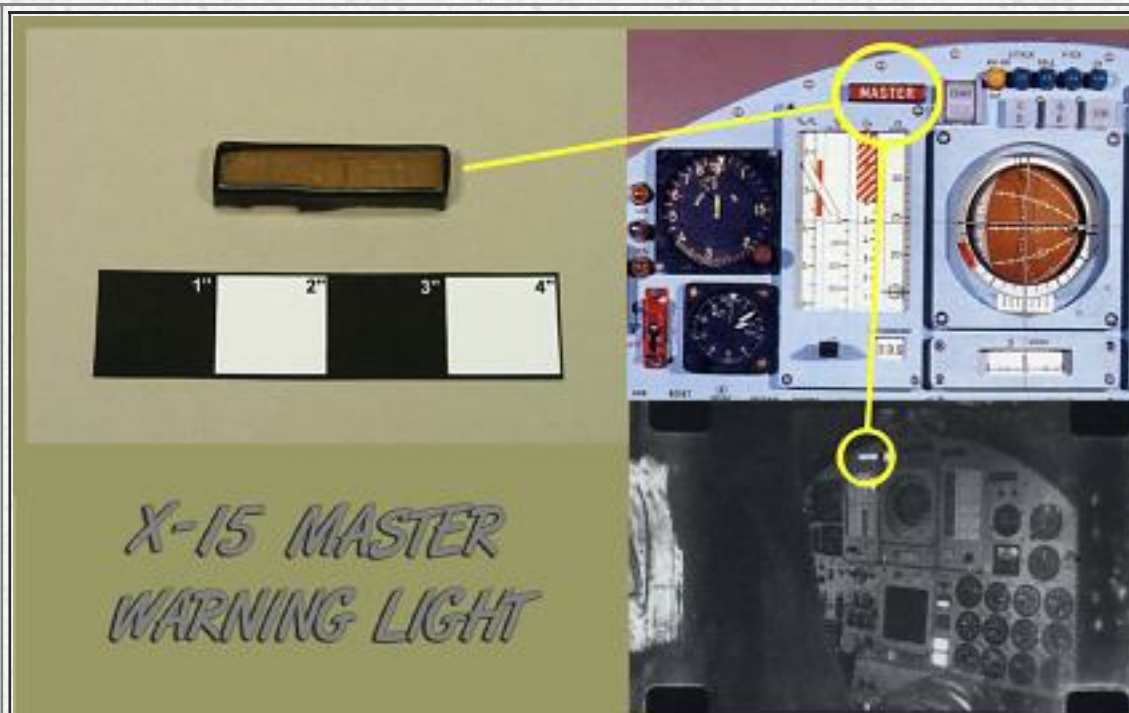
**X-15 MASTER WARNING LIGHT** THIS MASTER WARNING LIGHT WAS LOCATED ON THE UPPER LEFT SIDE OF THE #3 X-15's MAIN INSTRUMENT PANEL (CIRCLED IN THE UPPER RIGHT PHOTO). THE LIGHT ALERTED THE PILOT TO ANY CRITICAL FLIGHT SYSTEM PROBLEMS AND CAN BE CLEARLY SEEN ILLUMINATED IN ONE OF THE LAST FRAMES OF THE COCKPIT CAMERA'S FINAL FOOTAGE. (CIRCLED IN THE LOWER RIGHT PHOTO)

A careful search revealed artifacts that further confirmed the identity of the site. The MASTER warning light, and placards unique to the MH-96 computer console, were indisputable evidence that this debris was part of the third X-15.

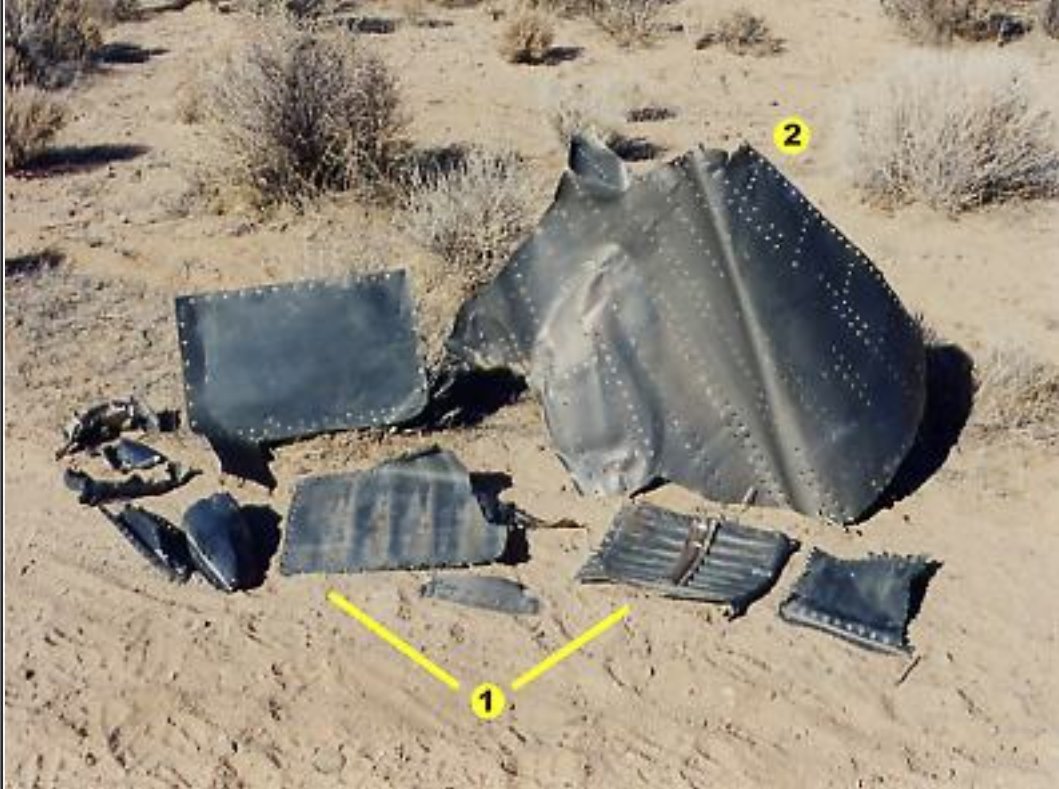
**X-15 FUSELAGE PIECES** 1. VARIOUS AIRCRAFT PANELS AND DEBRIS BLOWN OFF THE FUSELAGE AS IT BROKE UP  
2. LARGE SECTION OF INCONEL-X WING SKIN RIDDLED WITH HOLES CREATED WHEN IT WAS TORN AWAY FROM THE RIVETS HOLDING IT TO THE WING'S STRUCTURE AT SPEEDS IN EXCESS OF 2,000 MPH

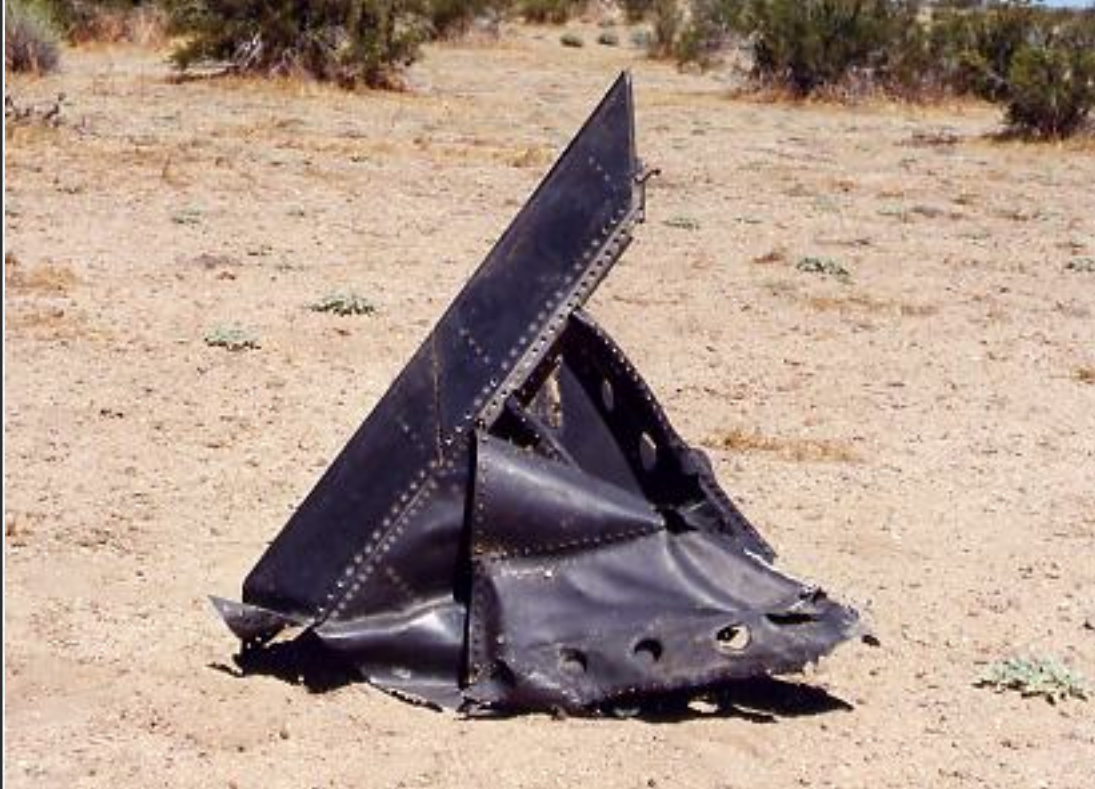
**X-15 HORIZONTAL STABILIZER SECTION** THIS IS THE FORWARD CENTER SECTION OF THE X-15's RIGHT HORIZONTAL STABILIZER. ITS IMPACT WITH THE GROUND FLATTENED ONE SIDE LEAVING IT STANDING IN THE DESERT, LEADING EDGE POINTED TO THE SKY, JUST AS WE FOUND IT. THIS ARTIFACT IS NOW PART OF THE AIR FORCE FLIGHT TEST CENTER MUSEUM COLLECTION

The most massive find was a 35-pound piece of the left horizontal stabilizer. This piece and several others (including the tail number) were donated to the Air Force Flight Test Center Museum at Edwards.

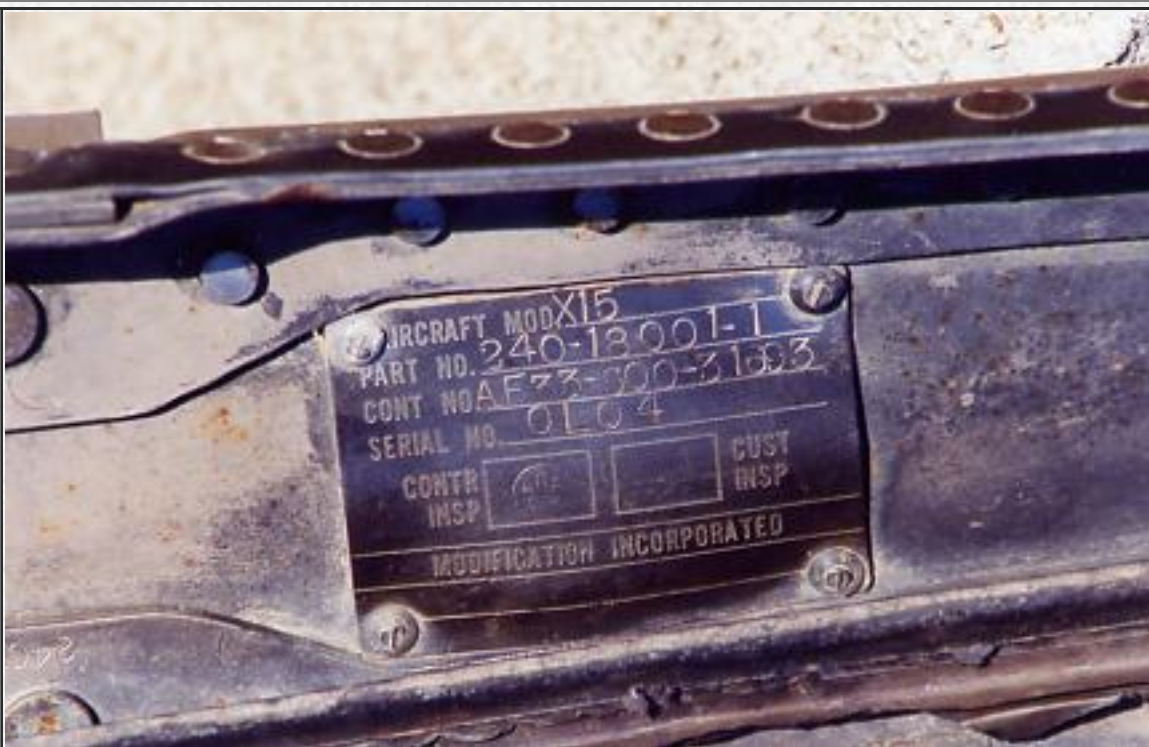
**X-15 AIRCRAFT DATA PLATE** CLOSE UP OF AN AIRCRAFT DATA PLATE ATTACHED TO WHAT WAS ONCE THE INNERMOST STRUCTURAL EDGE OF THE RIGHT WING FLAP. ON IT CAN BE SEEN THE DESIGNATION "X-15", THE AIRCRAFT'S PART NUMBER AND A NORTH AMERICAN AIRCRAFT INSPECTION STAMP THAT MADE THIS ARTIFACTS IDENTIFICATION RATHER EASY

Pete and Tony spent the next two years combing the debris field during seven expeditions. They found more than 50 pieces totaling over 125 pounds. Some of the more spectacular finds included various access panels, part of a wing with a reaction control system (RCS) thruster, parts of both sides of the upper vertical tail with remnants of the numbers "72", and most of the right flap (in several pieces). An X-15 data plate was attached to the inboard edge of the flap.

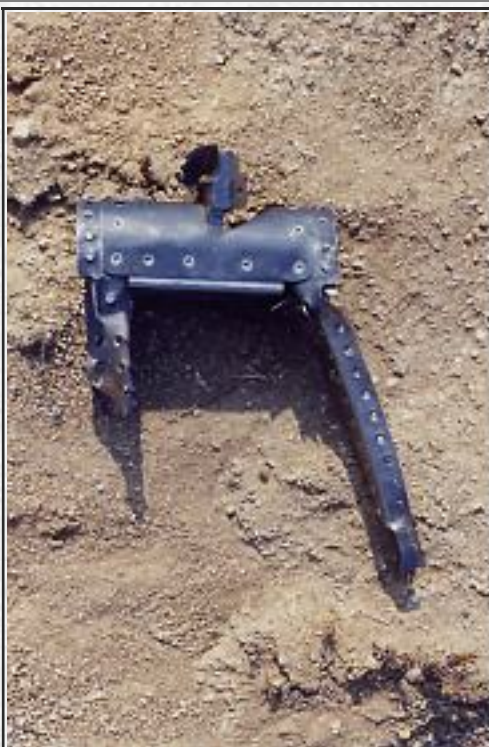
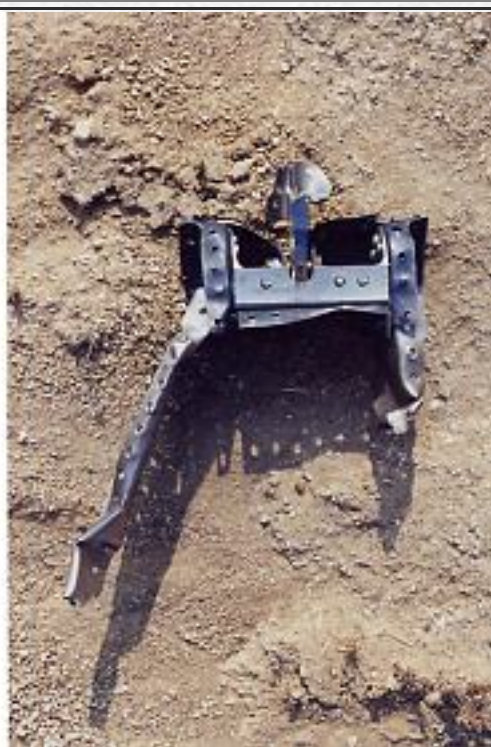
**X-15 FLAP HINGE** FRONT AND REAR VIEW OF A TITANIUM FLAP ATTACHMENT HINGE THAT WAS TWISTED AWAY FROM THE X-15's WING AS THE FLAP WAS TORN APART AT SPEEDS IN EXCESS OF 2,000 MPH

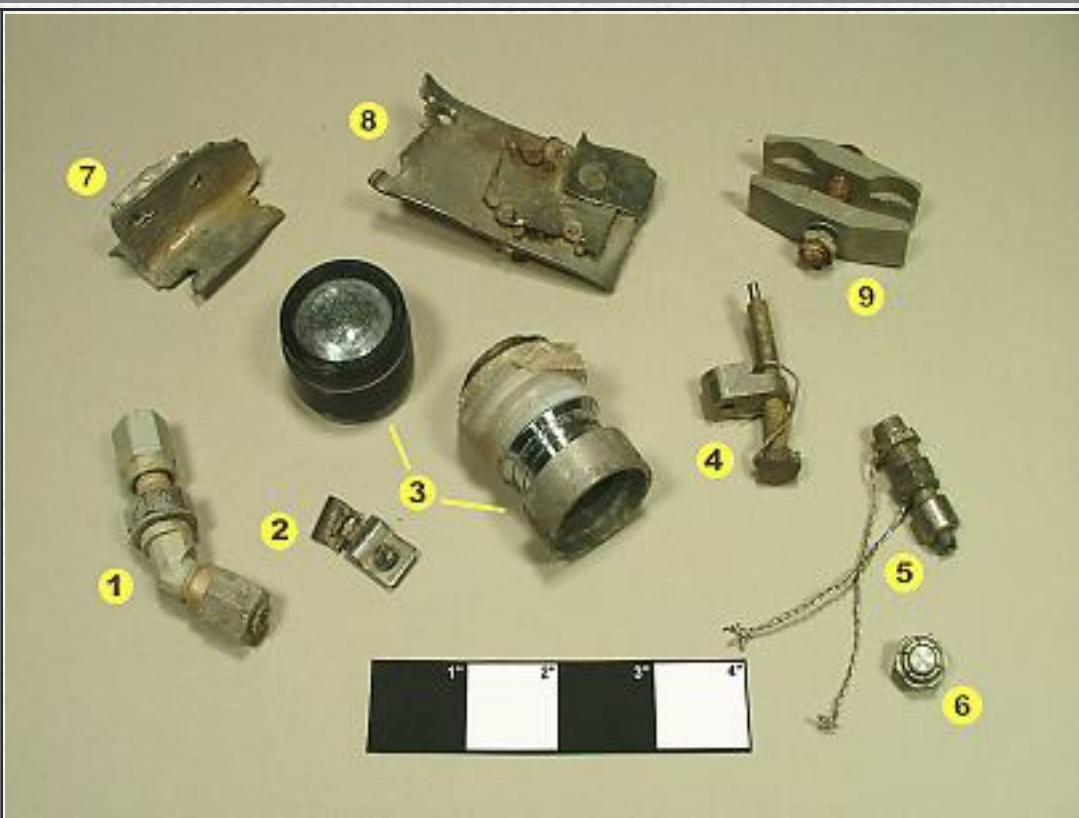
**X-15 ENGINE SECTION PARTS** THESE ARTIFACTS WERE RECOVERED FROM THE ENGINE SECTION SITE

1. SMALL AIRCRAFT ENGINE FITTING 2. SMALL HINGE 3. LENS  
PIECES FROM REAR FACING 16MM CAMERA. THE CAMERA WAS  
LOCATED BELOW THE UPPER SPEED BRAKES AT THE BASE OF  
THE VERTICAL STABILIZER 4. ADJUSTING BOLT, STILL SAFTEY  
WIRED 5. SMALL AIRCRAFT FITTING, STILL SAFETY WIRED 6.  
HIGH STRENGHT AIRCRAFT FASTENER SHEARED OFF WITH BOLT  
END 7. AIRCRAFT INTERNAL STRUCTURE 8. AIRCRAFT INTERNAL  
STRUCTURE WITH SMALL FRAGMENT OF INCONEL-X AIRCRAFT  
SKIN ATTACHED 9. TUBING CLAMP

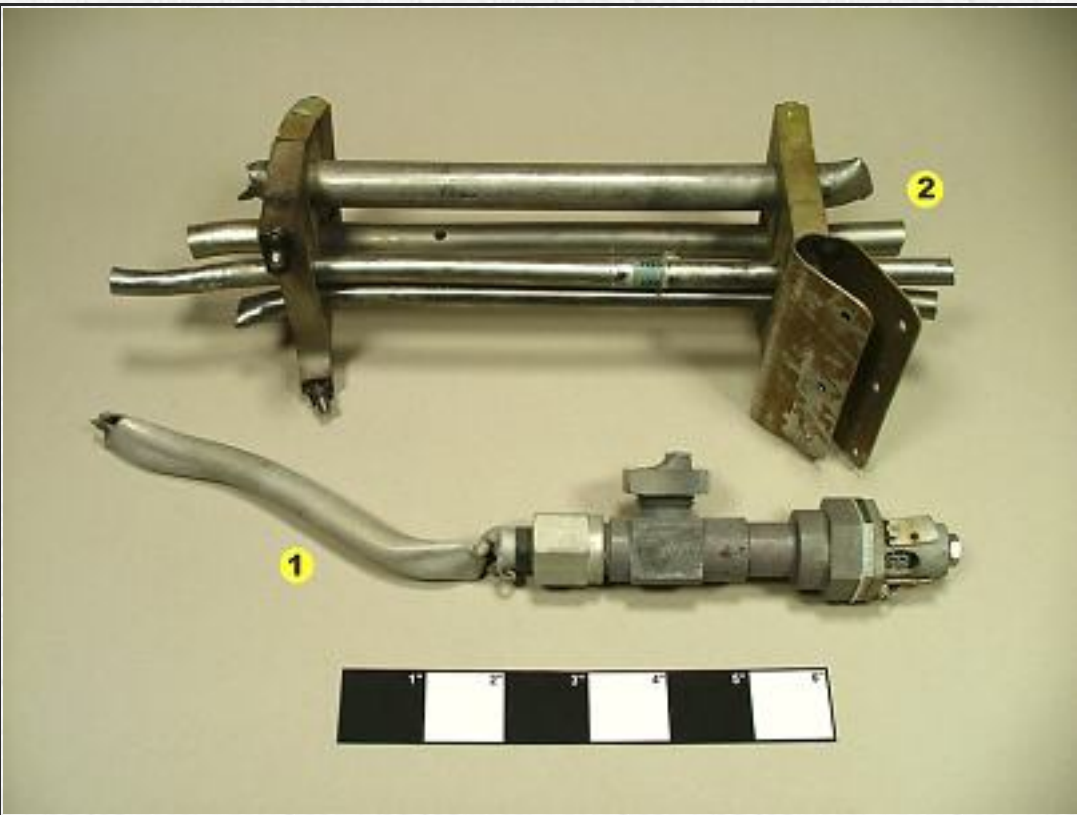
**X-15 PIPE BUNDLE & VALVE** 1. AIRCRAFT NITROGEN  
SYSTEM PRESSURE RELIEF VALVE  
2. TUBING BUNDLE AND GUIDES. NOTE PARTIAL HYDROGEN  
PEROXIDE IDENTIFICATION LABEL ON FOREMOST TUBE.

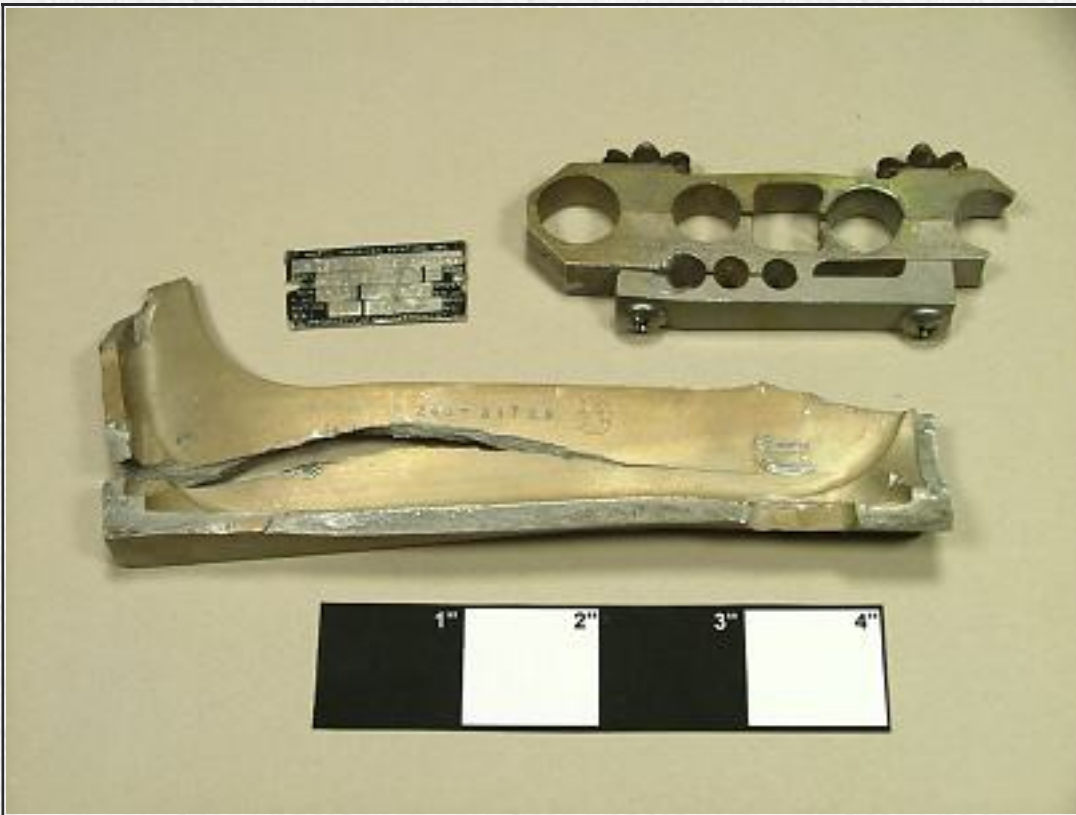
**X-15 PART NUMBERS & INSPECTION STAMPS**  
SEVERAL PARTS SHOWING NORTH AMERICAN AVIATION  
MANUFACTURER INSPECTION STAMPS AND PART NUMBERS.  
THESE ARE USED TO CONFRIM THE AIRCRAFT'S IDENTIFICATION

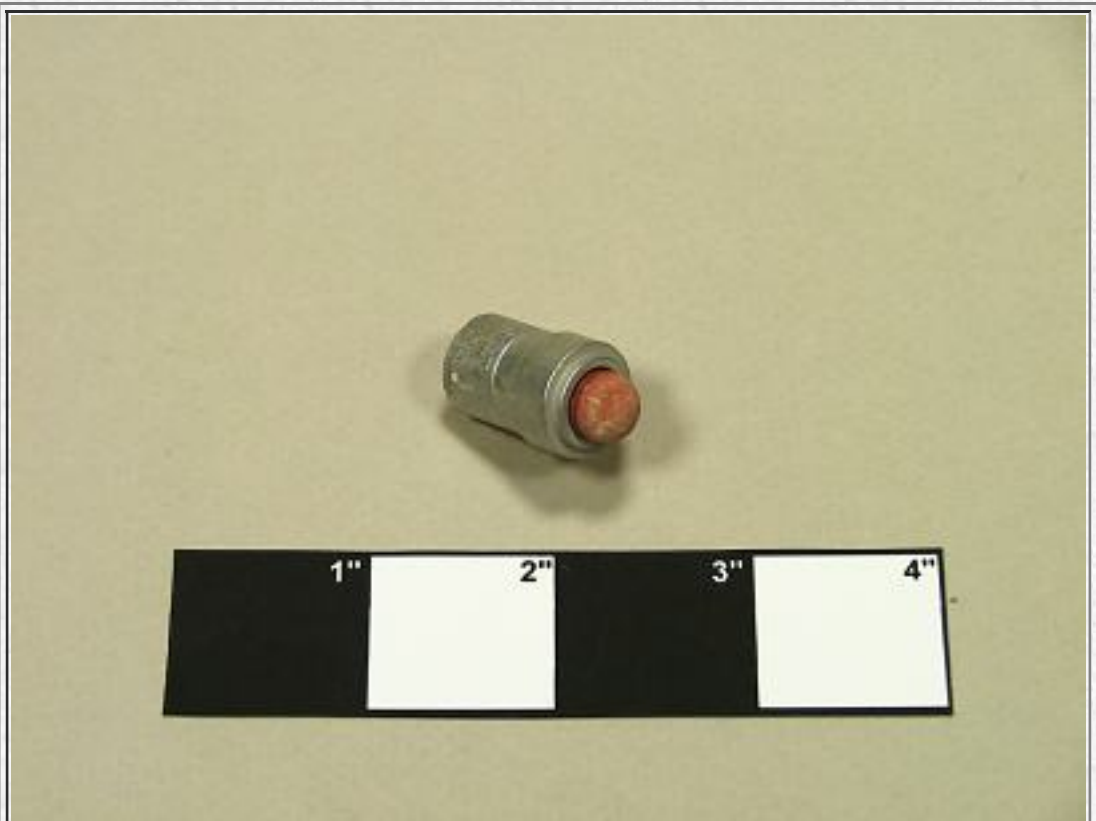
**X-15 PILOTS MIC SWITCH** THIS MICROPHONE SWITCH  
WAS LOCATED ON THE X-15's STICK GRIP. THUMB ACCUATED, IT  
WAS USED BY THE PILOT TO COMMUNICATE
