Nicolas BARDOU
Director, Flight Safety

Hard Landing, a Case Study for Crews and Maintenance Personnel

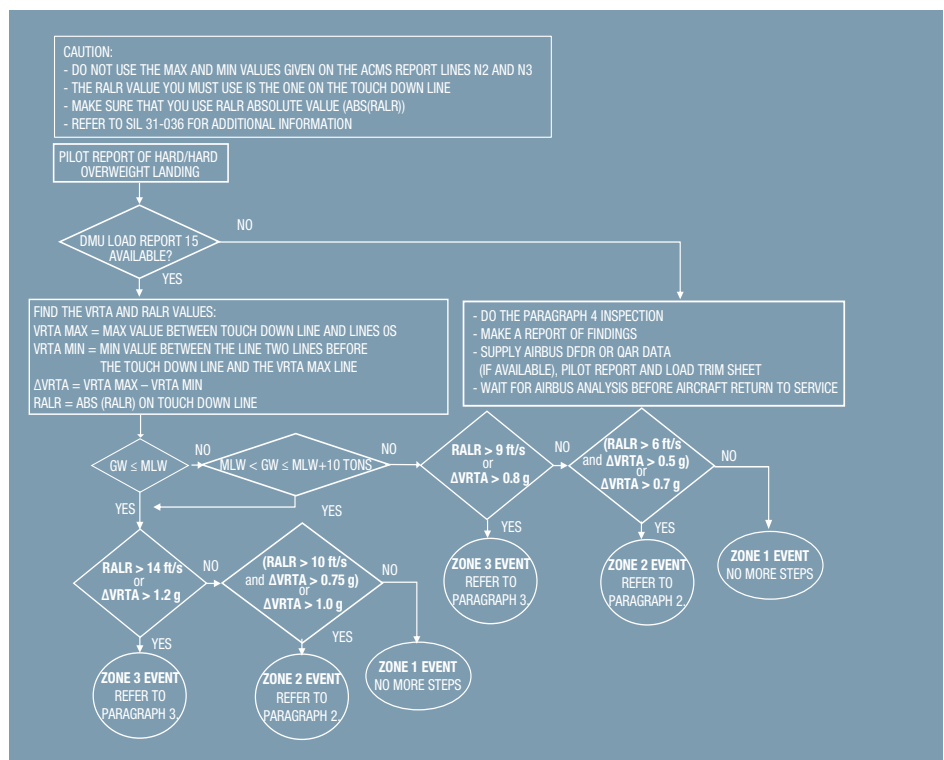
Figure 2
Hard landing flowchart to be added to the A330/A340 AMM in April 2014

To avoid any possible confusion, A330/A340 AMM 05.51.11 will be amended in April 2014 to include:

- A modified wording of the first phrase of the above procedure, which now reads: "If load report 15 or the DFDRS data are not available or you cannot read them..."
- A flowchart to guarantee the same level of readability as on the A320 Family AMM (fig 2).

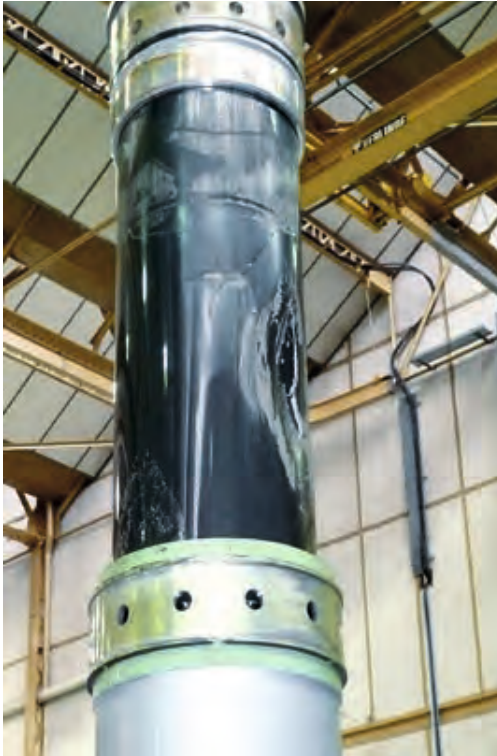
However, by 150 ft radio altitude, the aircraft is above the glide by more than one dot and two nose-down inputs are applied. The rate of descent increases to -1,100 ft/min and the EGPWS alert "SINK RATE" sounds twice, the second time below 50 ft. Despite a nose up input during the flare the aircraft impacts the ground at -1,260 ft/min with a vertical acceleration of 2.74 g.

Figure 3
Damage on the aircraft following the hard landing:
aircraft's Landing Gear

After take-off, due to the damage sustained during the hard landing, the landing gear failed to retract and the flight crew elected to perform an In Flight Turn Back after enough fuel was burnt to land below MLW. The aircraft landed safely.

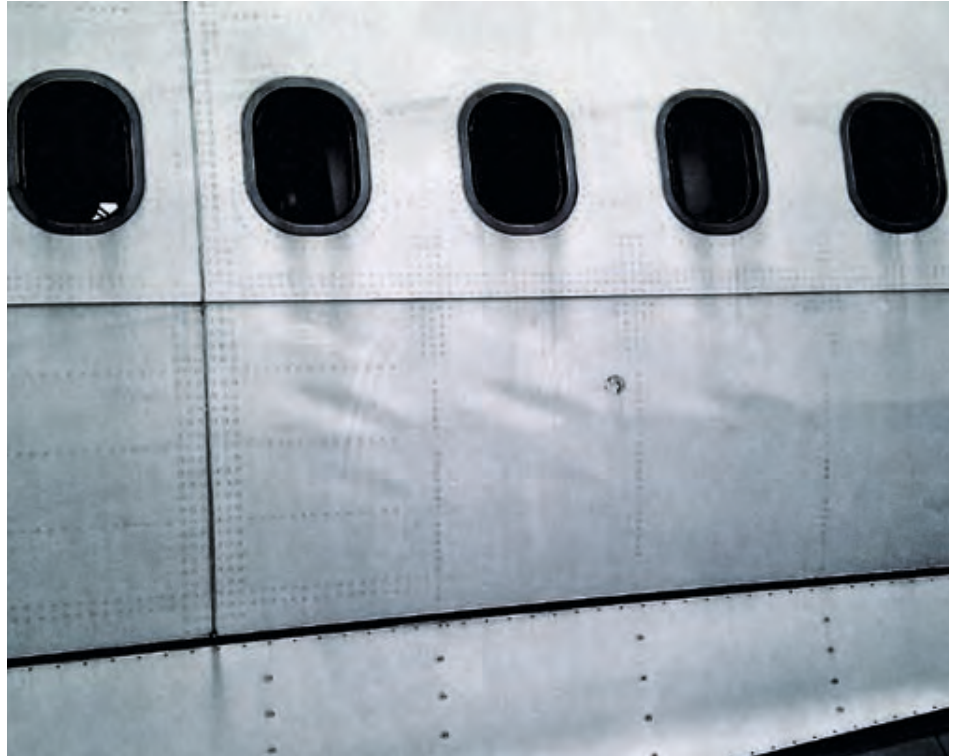
Figure 4
Damage on the aircraft following the hard landing: ripples on the fuselage
